Juno Final Report,
Volume III,

Juno II: Earth Satellites (U)

June 28, 1962

C. F. Mohl

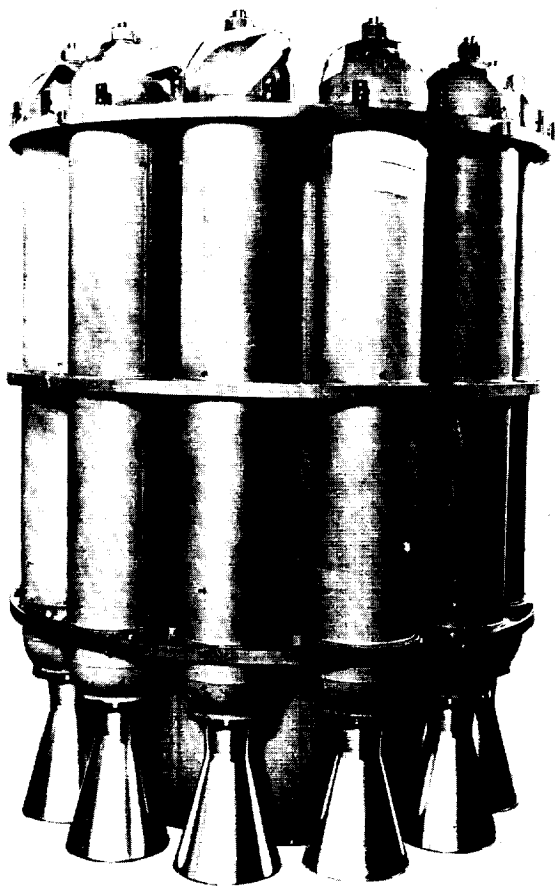
Fig. 6. Stage 2 motor assembly

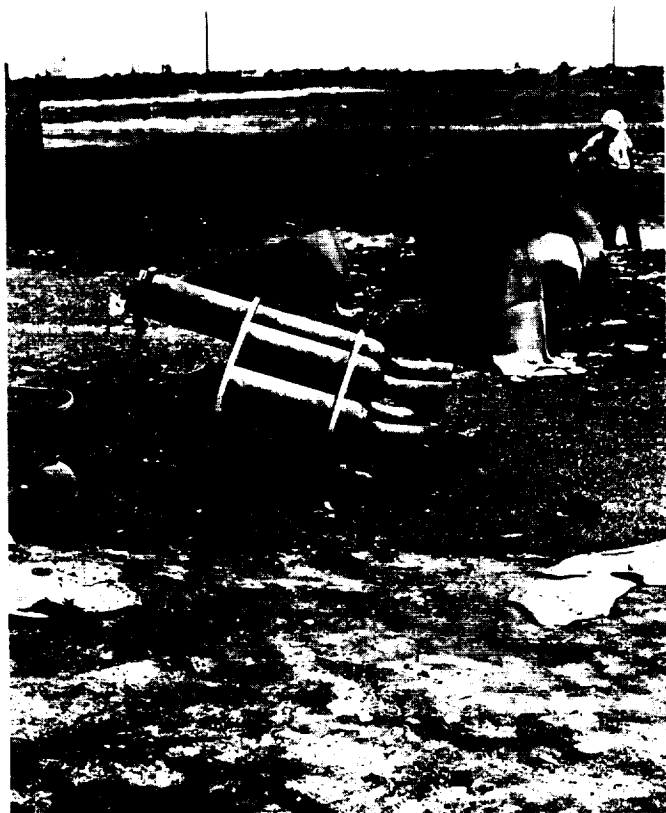
Fig. 11. Assembly II and launcher, postflight

At liftoff the missile deviated to the west in an obviously erratic manner. Cutoff and destruct commands were sent by the Range Safety Officer at about 5½ sec of flight. Impact occurred about 250 ft northwest of the pad 5 launch table and 300 ft southwest of the blockhouse. Personnel at the blockhouse window had observed at least one upper stage rocket motor burning at both ends after missile destruct; most of the solid propellant and all booster Ordnance items were consumed by the ensuing fire after impact. Cluster motor cases, the instrument compartment, and payload were found within a circle of less than 100-ft diameter. Figures 11, 12, and 13 show assembly II and launcher, assembly III, and assembly IV, respectively. No propellant was found during the initial examination, but on closer scrutiny the following day, several pieces were found totaling about 5 lb. This propellant, as well as most of the rocket motor cases and other cluster parts, was returned to JPL for examination.

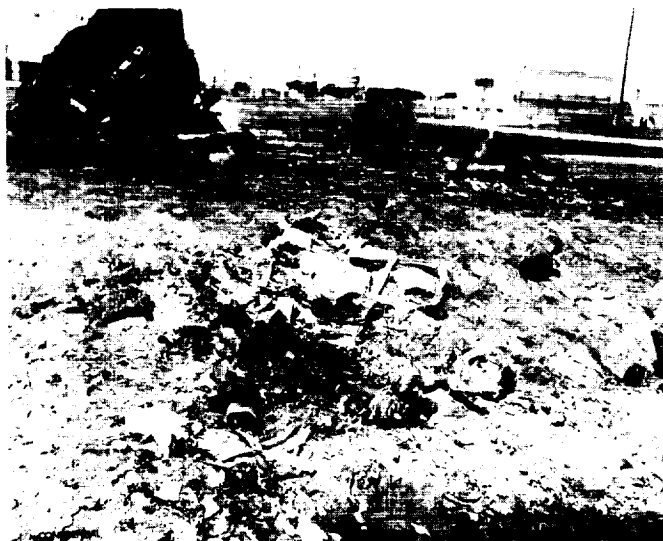
Fig. 12. Assembly III, postflight

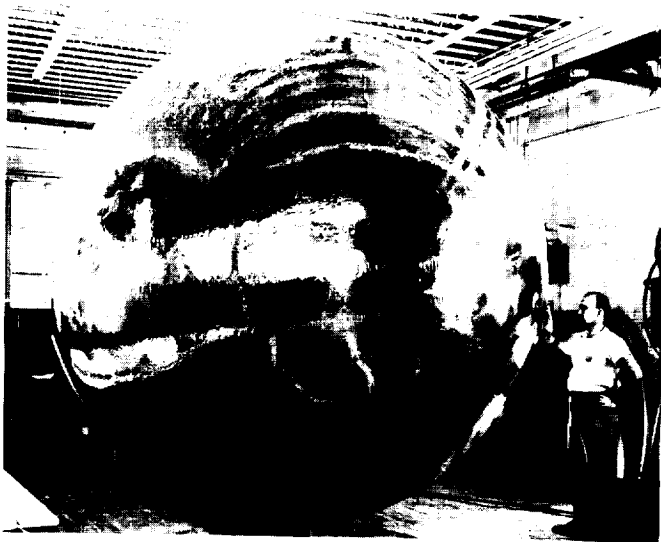
Fig. 17. Twelve-foot inflatable sphere
